# Manhole Inspection Summary

Manhole # S39MM\_013MH

Insp Date: **3/1/07 12:40 PM**

**Location** Address: **1014 20TH ST**

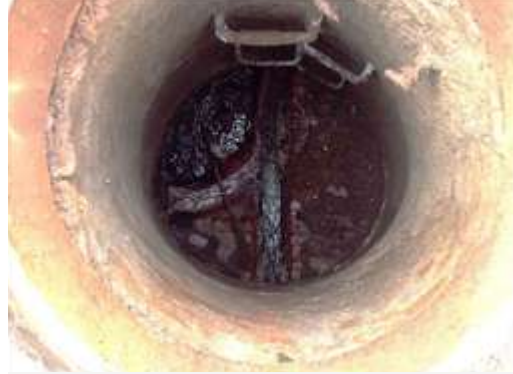
Top View

Corroded and missing steps. Evidence of surcharge - Bench debris.

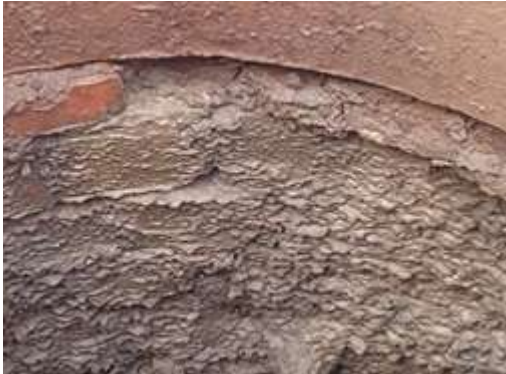
Defect

Frame leaks. Adjsutment deterioration and infiltration.

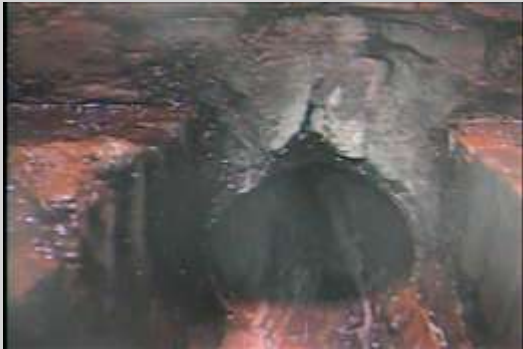
### 8 in. Circular Gravity Sewer Pipe Out @ 12 O'Clock

Infiltration: **Evidence** Pipe Seal Cond: **Cracked**

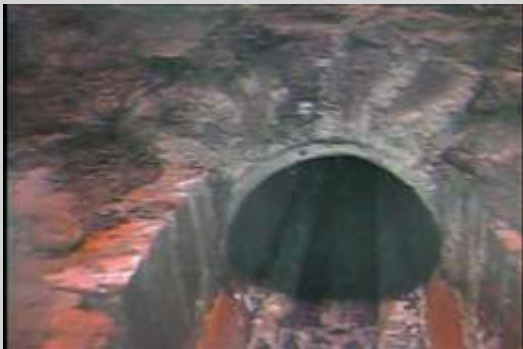
### 8 in. Circular Gravity Sewer Pipe In @ 6 O'Clock

Deposits: ☐ None ☒ Mud ☐ Sludge ☐ Debris ☒ Grease

Silt Depth: **0** (in.) Deposits Extent: **Light**

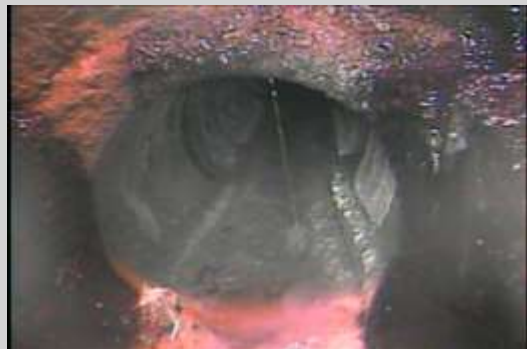
Pipe In @ 9 O'Clock

Deposits: ☐ None ☐ Mud ☐ Sludge ☐ Debris ☒ **Grease**

Deposits Extent: **Light**
